# OMAP-L138 C6000 DSP+ARM® Processor Silicon Revisions 2.3, 2.1, 2.0, 1.1 and 1.0

## Silicon Errata

Literature Number: SPRZ301M

June 2009–Revised March 2014

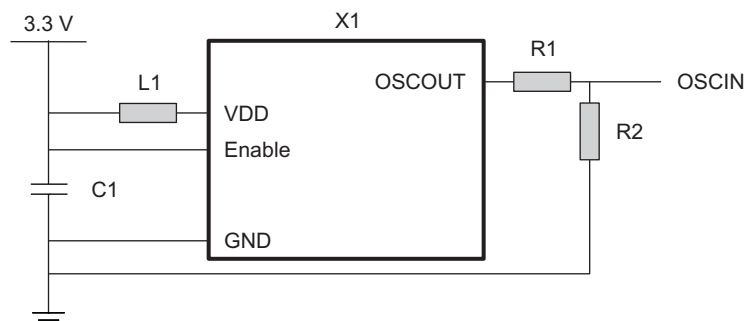
**Figure 2. External 3.3V Clock Source**

On all silicon revisions, certain design elements make this device susceptible to radiated noise during an ESD strike, as described in the standard IEC 61000-4-2. Exposure to the electrical noise caused by the ESD can cause soft device failures due to noise coupling on the system clock (OSCIN). ESD events within the IEC spec range do not cause permanent device damage and full functionality is recoverable with a device reset. The sensitivity to this noise issue is primarily due to the 1.2V oscillator/clock input implemented on this device. The low voltage range, coupled with slow rise and fall times, provides a lower noise margin than other TI devices with higher voltage internal oscillators (for example, 1.8V or 3.3V oscillators).

If ESD robustness is a concern, it is strongly recommended to avoid using the internal oscillator as a clock source. An external 3.3V clock source with a resistor voltage divider as in [Figure 2](#) can be used to externally generate the required 1.2V input clock. By using an external clock input with fast rise/fall times (less than 5 ns), the noise margin improves significantly, increasing ESD noise resistance.

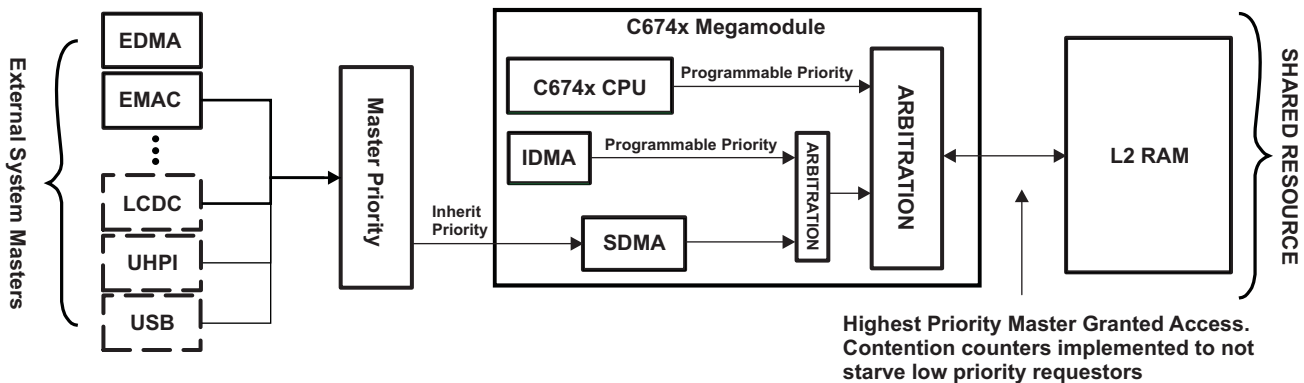
**Figure 3. Priority Arbitration Scheme for L2 RAM**

The C674x Megamodule uses a bandwidth management (BWM) system to arbitrate between DMA and CPU requests issued to L2 RAM. See TMS320C674x DSP Megamodule Reference Guide, Literature Number - [SPRUFK5](#) for more information on the BWM. BWM arbitration grants L2 bandwidth based on programmable priorities and contention- cycle-counters. The contention-cycle-counters count the number of cycles for which the associated L2 requests are blocked by higher priority requests. When the contention-cycle-counter reaches a programmed threshold (MAXWAIT), the associated L2 request is granted a slice of L2 bandwidth. This prevents indefinite blocking of low priority requests when faced with the continuous presence of higher priority requests.

Ideally, the BWM arbitration will grant equal L2 bandwidth between equal priority DMA and CPU requests. Instead, when equal priority DMA and CPU requests arrive at the BWM, bandwidth is always granted in favor of the CPU over DMA. In the case of successive CPU requests, it is possible for the CPU to block all DMA requests until CPU traffic subsides. Additionally, some command logic in the BWM uses priority level 7, which can also result in SDMA stalls when the CPU is also programmed to priority level 7. [Figure 3](#) shows a high level diagram of the arbitration scheme used for L2 RAM requests.

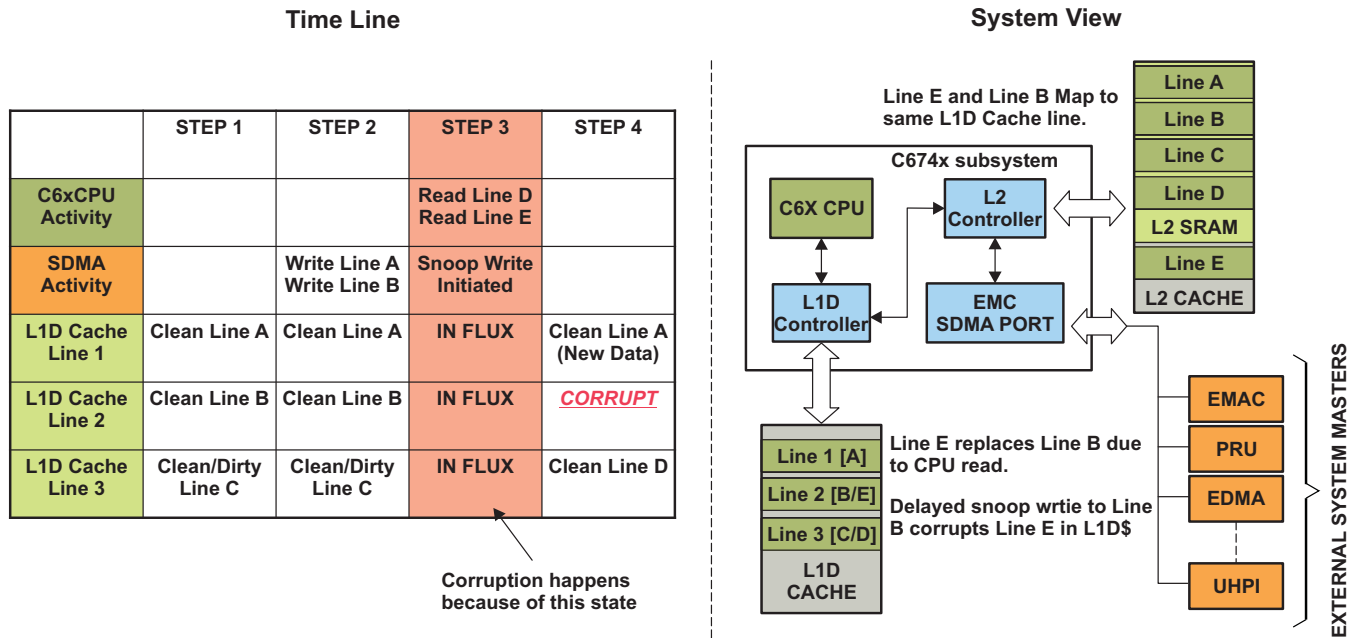
**Figure 4. Example of L1D Cache Corruption**

An L1D cache-line corruption event occurs when all of the conditions in the following steps are met (see [Figure 4](#)):

- Line E in L2 cache is read as a cache hit. Line E is destined to replace Line 2 in L1D Cache, which also has a snoop write pending for the updated Line B content.

- Line D in L2 SRAM is read. Line D will replace Line 3 in L1D cache.
4. When the snoop write operation completes, Line 2 in L1D cache now contains the updated L2 SRAM Line B data instead of the L2 cache Line E data.

The correct behavior would have been to kill the pending snoop write initiated to update L1D cache Line 2 with the updated L2 SRAM Line B data in Step 3. The L1D cache should have evicted Line B and replaced it with Line E data. Instead, the snoop write operation continues and does not complete until after the L1D cache Line 2 has already been replaced with L2 cache Line E data. The snoop write instruction overwrites the L1D cache Line 2 (containing L2 cache Line E data) with the updated L2 SRAM Line B data.

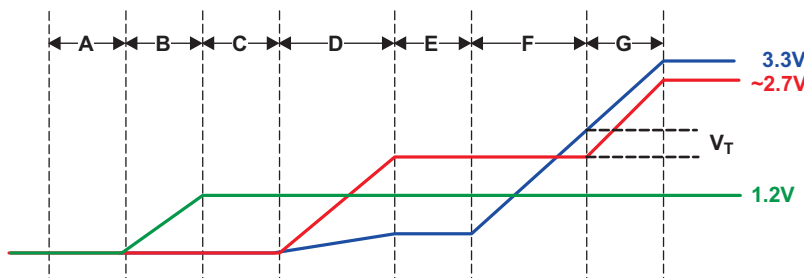
**Figure 6. Faulty power-supply ramp**

The behavior is the same until zone G. When the DVDD3318\_x supply exceeds DVDD18 by a transistor  $V_T$ , the DVDD18 supply begins to be pulled up by the DVDD3318\_x supply and follows the DVDD3318\_x supply by  $DVDD3318_x - V_T$ . Since the DVDD18 supply is often connected to other 1.8V supplies in the design, these other supplies can be pulled up also.

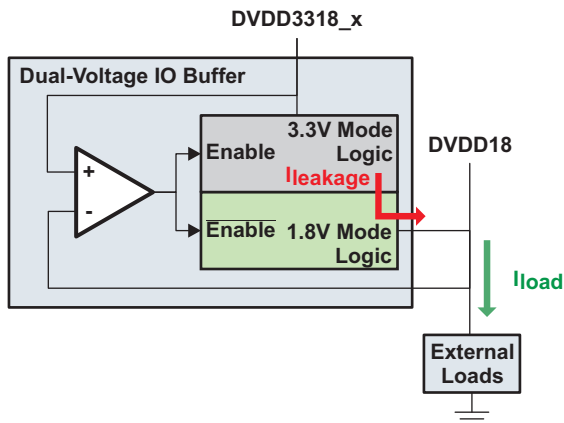
Figure 8. Error State of the IO buffer during Zone G

As DVDD3318\_x exceeds DVDD18+V<sub>T</sub>, some of the circuitry across the boundary of the two voltage domains will turn on and causes a leakage current (in red) to flow between the two voltage domains. This current pulls up the DVDD18 supply unless the power source providing that supply can oppose it or unless the load current is strong enough to counteract it.

If DVDD18 continues to rise as DVDD3318\_x ramps, the comparator never sees enough difference between the two supplies to switch to 3.3V mode.

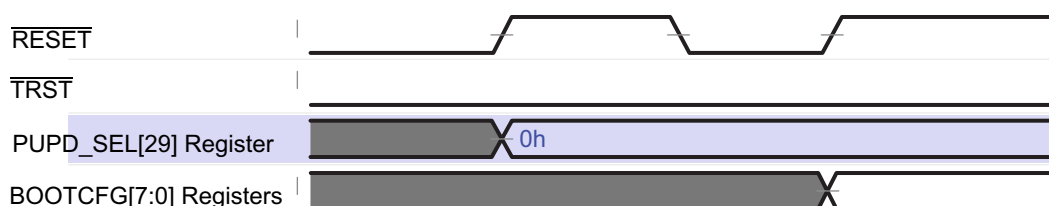
**Figure 10. Initialization of PUPD\_SEL[29] and BOOTCFG[7:0] Registers with Weak or No External Pull Resistors on BOOT[7:0] Pins**

Internal pullups being enabled on the BOOT[7:0] pins may result in boot failures. If weak external pulldown resistors are used on the PCB to select the boot mode, they may not be able to overpower the internal pullups. This can result in the wrong boot mode being latched in the BOOTCFG[7:0] register when coming out of Reset.

Once the device is out of Reset, the PUPD\_SEL[29] register is initialized, and the internal pulldown resistors for the BOOT[7:0] pins are all enabled. Issuing a second Power-On Reset ( $\overline{\text{POR}}$ ) results in the intended boot mode being latched, since the pins are internally pulled down as expected.

Figure 10 shows the behavior of the PUPD\_SEL[29] register before and after reset. Assuming weak or no external pull resistors are on the BOOT[7:0] pins, the BOOTCFG register will latch the unknown values after the device initially comes out of Reset. Note that, TRST *must* always be low in order to issue a POR and latch the boot pin values -- the boot pins are not latched after a Warm Reset.

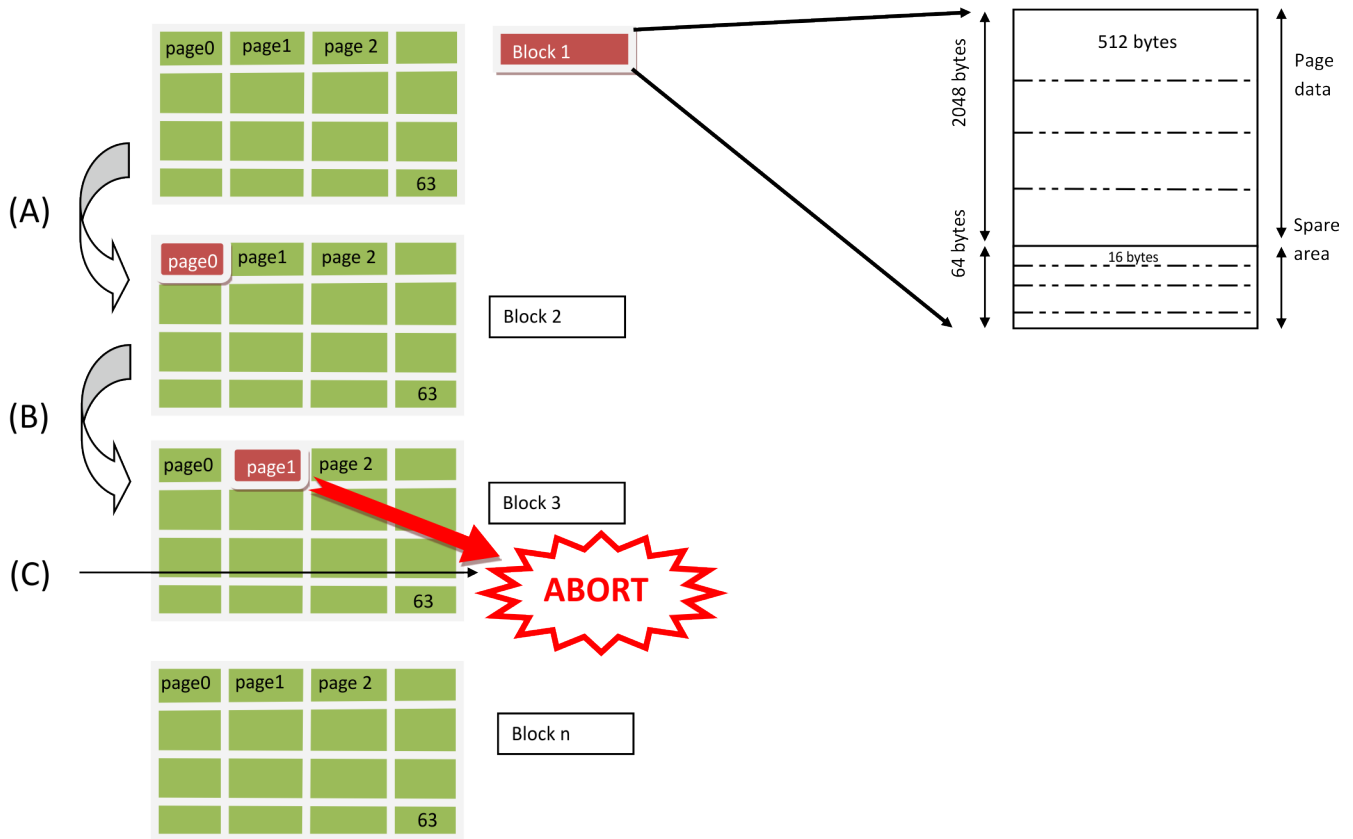
**Figure 11. D800K008 ROM Behavior Before Application of Software Patch<sup>(1)</sup>**

If page0 of the good block has an ECC data error or an uncorrectable error (more than 4 bit errors combined), the RBL skips to the next block (shown as (B) in [Figure 11](#)). This bad block check mechanism enables the device to check up to the first 32 blocks in the NAND flash for booting (the boot process will fail if all 32 blocks have uncorrectable or ECC data errors in page0). Note that the RBL does not abort on detecting an error in ECC data on page0.

Once the RBL finds a good block with a good page0, it continues to read subsequent pages in that block. If an uncorrectable or ECC error is detected in subsequent pages, the RBL will abort with a boot error (shown as (C) in [Figure 11](#)). The workaround, described below, enables the boot process to continue for both types of errors (ECC data and uncorrectable errors).

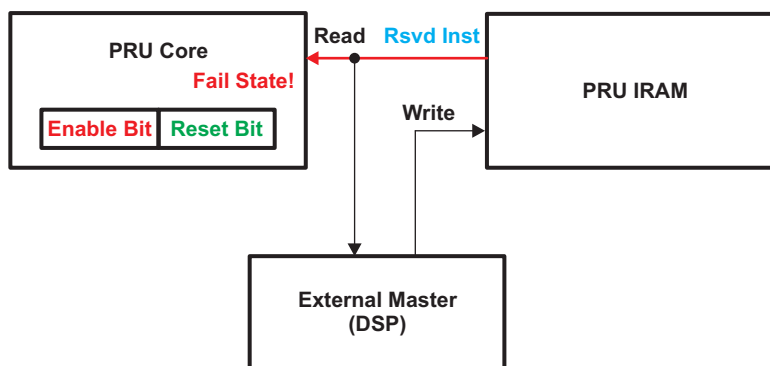
**Figure 14. Boot Failure on Power-On**

When the device is first powered-on, the read bus from the PRU IRAM is not initialized and will contain random values (see Figure 14). Under unpredictable circumstances, the random value on the read bus may resemble a reserved instruction which can be interpreted by the PRU when the core is reset and not enabled.

If the PRU core executes this reserved instruction, it will not be able to properly execute the first functional op-code in the PRU IRAM when the core is later enabled. In this fail state, the PRU will never acknowledge to the DSP that the reset vector table was successfully initialized and the DSP will be stuck in a polling loop waiting for the PRU to complete its task.

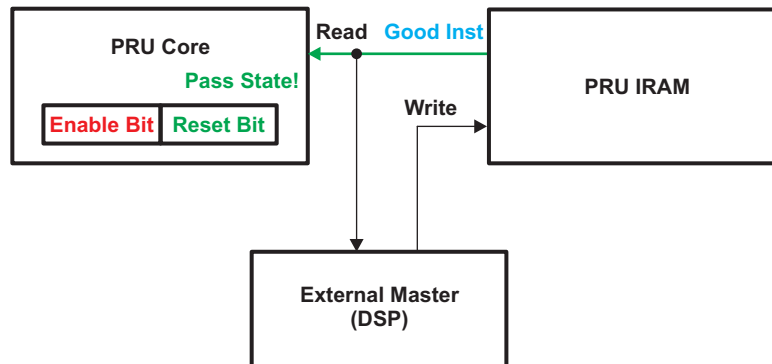
**Figure 15. Secondary Reset**

Although the PRU core execution is stuck, the PRU IRAM read bus is now initialized with a non-reserved instruction that was fetched from the IRAM by the PRU core (see [Figure 15](#)). If a secondary reset is provided to the device (either POR or WARM), the PRU will be able to execute its functional instructions as expected.

Note that in order to recover from this fail state with a secondary reset, the DSP must be allowed to execute its boot ROM up to the point where the PRU has fetched a known instruction from the PRU IRAM. The approximate count of 15k cycles into the boot ROM is sufficient.

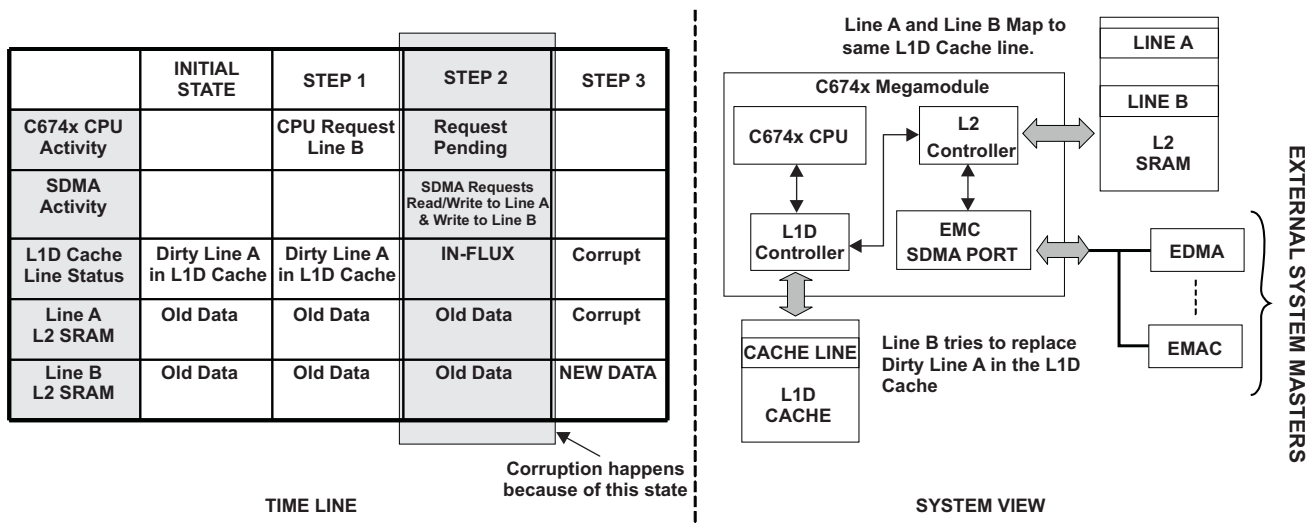
**Figure 20. Example of L1D Cache and L2 RAM Corruption**

1. L1D cache evicts a dirty line (Line A) while allocating a new line (Line B) in the same set/way (cache Lines A and B consist of 64-bytes each). In order for this to happen, the following will have taken place:
  - (a) Line A was previously read by CPU because L1D is a read-allocate cache,
  - (b) Line A is dirty because its value was modified by CPU, and
  - (c) Line B is read by CPU
2. Both Line A and Line B are associated with L2 RAM, and
3. While the original L1D victim write-back from condition (1) is in progress, the SDMA performs both:
  - (a) a read or write operation to Line A in L2 RAM and
  - (b) a write operation to Line B in L2 RAM.

If all of the above conditions are met, the L2 RAM data associated with the Line A victim writeback will become corrupt. Additionally, the Line B data originating from the SDMA write will also become corrupt in L1D cache. [Figure 20](#) shows an example scenario of L1D cache and L2 RAM corruption.

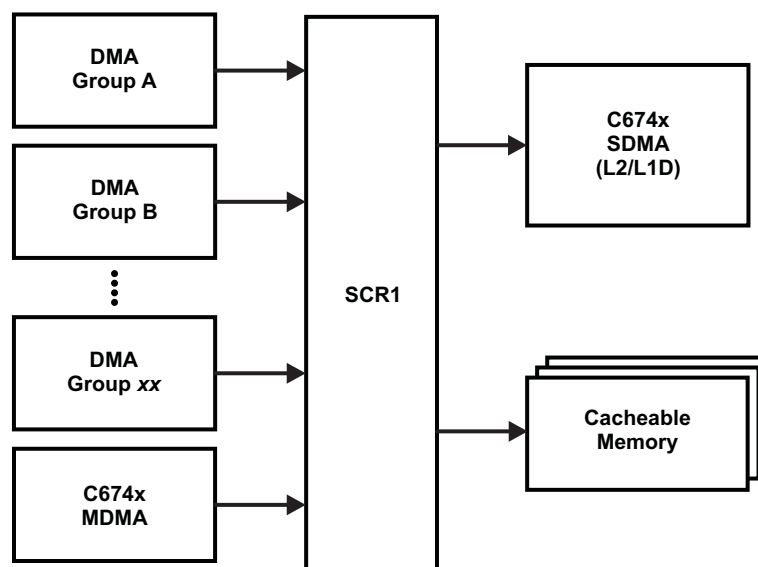
Figure 22. SCR1 System Interconnect

Step 2: The DSP's SDMA asserts itself as not ready and is unable to accept the write data from Step 1, and a cache line writeback is initiated from DSP memory to the same cacheable memory from Step 1. The cache line writeback command also passes through SCR1.

With the above scenario, it is possible for SCR1 to order the write commands from Step 1 in front of the write commands from Step 2. Due to the MDMA/SDMA blocking behavior, the SDMA commands from Step 2 will be waiting for the MDMA traffic from Step 1 to finish, resulting in a deadlock situation at SCR1. [Figure 22](#) is provided for illustrative purposes and is incomplete because of simplification.
