# OMAP-L138 C6000 DSP+ARM® Processor Silicon Revisions 2.3, 2.1, 2.0, 1.1 and 1.0

## Silicon Errata

Literature Number: SPRZ301M

June 2009–Revised March 2014

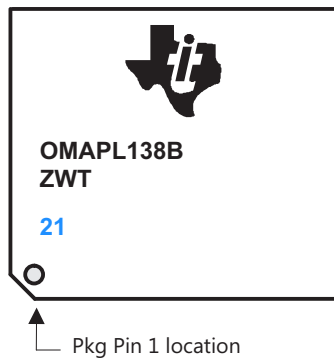
**Figure 1. Device Markings**

DEVICE REVISION CODE (xx)	SILICON REVISION	COMMENTS
E	2.3	
B	2.1	Silicon Revision 2.1 can be differentiated from Revision 2.0 by a top side '21' marking on the package. See <a href="#">Figure 1</a> for details. Additionally the ROM ID code may be used to distinguish Revision 2.1 from Revision 2.0
B	2.0	-
A	1.1	-
(blank)	1.0	-

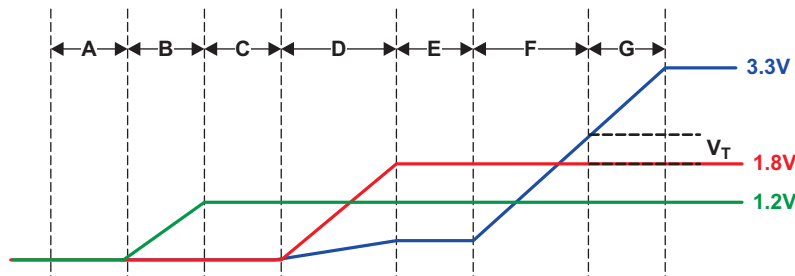
**Figure 5. Normal power-supply ramp**

**Important Note:** The 3.3V DVDD3318\_x supplies must not be driven to 0V during zones A – E or high current capable of damaging the device may occur. The 3.3V DVDD3318\_x supplies should not be driven during this time.

- A. All device supplies are undriven
- B. The 1.2V supplies are ramped to their nominal levels
- C. Potential delay between supply ramps (not required)
- D. The 1.8V supplies (specifically DVDD18) are ramped to their nominal levels. During the DVDD18 ramp there will be some minor drift up in the undriven DVDD3318\_x supplies. This is normal and is not a problem.
- E. Potential delay between supply ramps (not required)
- F. DVDD3318\_x is ramping but is less than DVDD18 +  $V_T$
- G. DVDD3318\_x is ramping but is greater than DVDD18 +  $V_T$

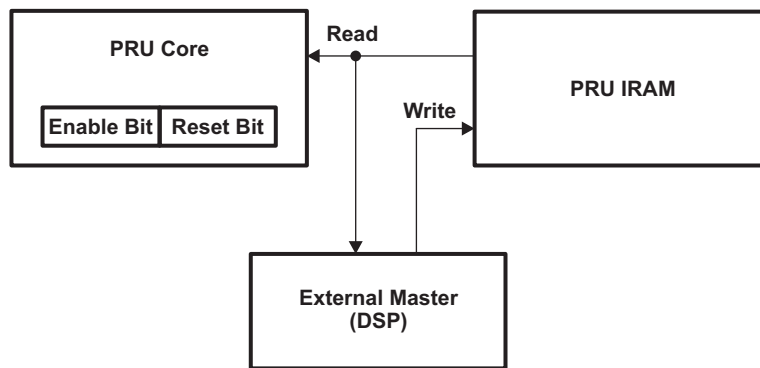
**Figure 13. PRU and DSP Block Diagram**

The ARM reset vector table is located in the ARM's local RAM, however the ARM local RAM can only be accessed by two bus masters: ARM and PRU0. Therefore, the DSP must program PRU0 to copy the desired reset vector table into the ARM's local RAM.

The PRU instructions are located inside of an instruction RAM (IRAM) which is initialized by the DSP during ROM boot (see Figure 13). After the instructions are stored to IRAM, the PRU is reset and enabled to execute its instructions. In this case, the PRU is instructed to initialize the ARM reset vector table.

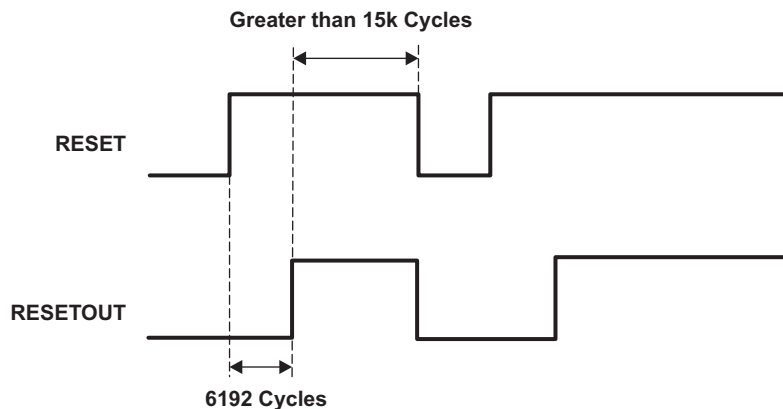
**Figure 16. First POR Reset Timing**

Note that in order to recover from this fail state with a secondary reset, the DSP must be allowed to execute its boot ROM up to the point where the PRU has fetched a known instruction from the PRU IRAM. The approximate count of 15k cycles into the boot ROM is sufficient.

The 15k clock cycle count does not include the 6192 clock cycles required to complete a device POR reset (see [Figure 16](#)). With a 24MHz crystal, the first RESET signal must be asserted high for at least 883us (or approximately 1ms).

Modify the target board so that the affected device is given a secondary reset on power-up as shown in [Figure 16](#). Two example methods are described in the sections that follow.

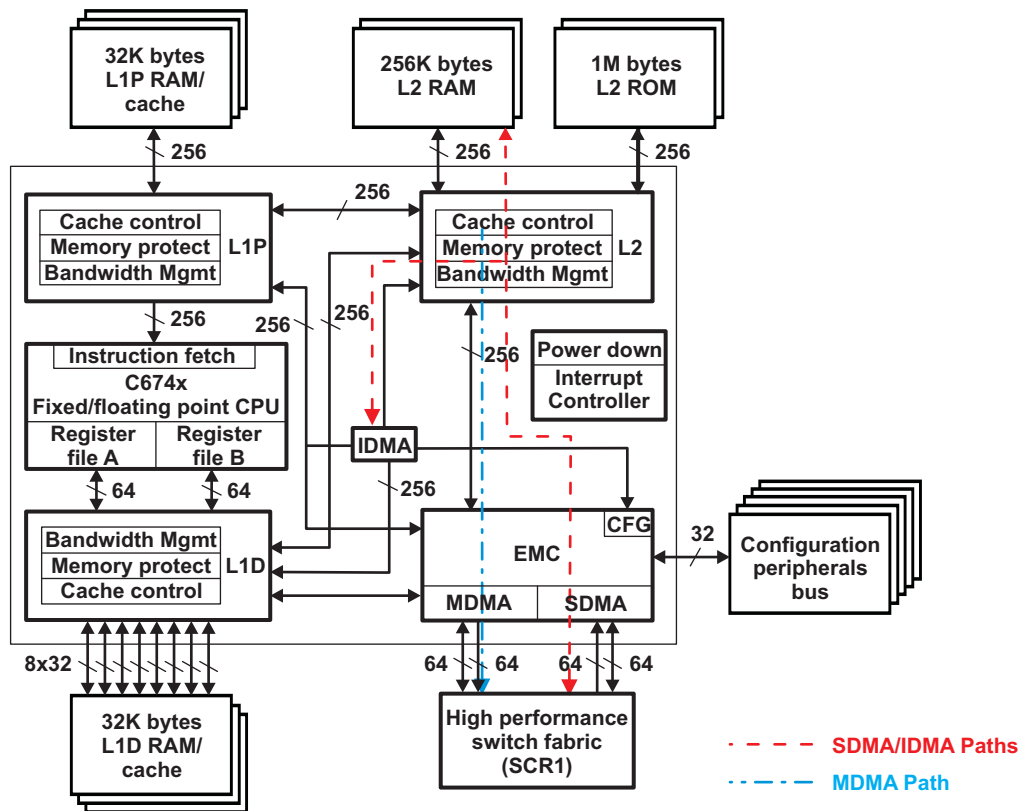
Figure 21. C674x Megamodule

Ideally, the MDMA (dashed-dotted line in Figure 21) and SDMA/IDMA paths (dashed lines in Figure 21) operate independently with minimal interference. Normally MDMA accesses may stall for extended periods of time due to expected system level delays (for example, bandwidth limitations). However, when using L2 as RAM, SDMA and IDMA accesses to L2/L1 may experience unexpected stalling in addition to the normal stalls seen by the MDMA interface. For latency-sensitive traffic, the SDMA stall can result in missing real-time deadlines. In a more severe case, the SDMA stall can produce a deadlock condition in the device. An IDMA stall cannot produce a deadlock condition.

**Note:** SDMA/IDMA accesses to L1P/D will not experience an unexpected stall if there are no SDMA/IDMA accesses to L2. Unexpected SDMA/IDMA stalls to L1 happen only when they are pipelined behind L2 accesses. Additionally, the deadlock scenario will be avoided if there are no SDMA accesses to L2.

Figure 21 is provided for illustrative purposes and is incomplete because of simplification. The IDMA/SDMA (dashed-lines) path could also go to L1D/L1P memories, and IDMA can go to DSP CFG peripherals. MDMA transactions can originate also from L1P or L1D through the L2 controller or directly from DSP).

The duration of the SDMA/IDMA stalls depend on the quantity/characteristics of the L1/L2 cache and the MDMA traffic in the system. Therefore, it is difficult to predict if stalling will occur and for how long.
